Cahermurphy West Wind Farm, Co. Clare

Stage 1 Road Safety Audit

March 2026

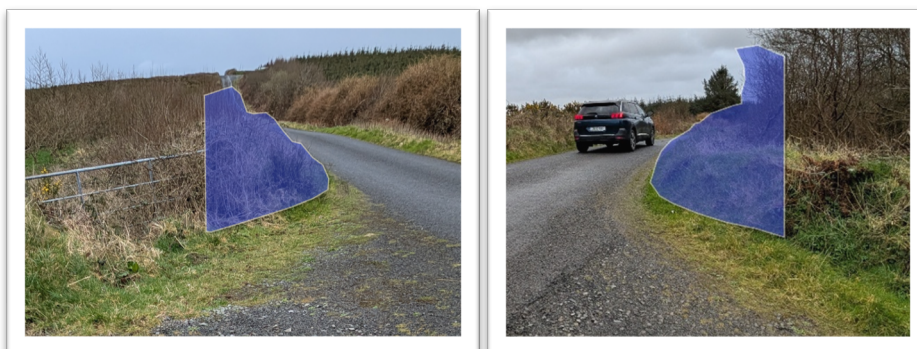
2.1 Problem: Visibility Splays Partially Obstructed by Vegetation

Location: Boundary Treatment Either Side of Access Road Junction Onto L-6254

Existing vegetation on both sides of the access junction may obstruct visibility, making it difficult for drivers joining the L-6254 to see approaching traffic and increasing the risk of rear-end or side-impact collisions.

Figure 2.1 – Existing Vegetation In Ditches Either Side of access road junction

The Designer should ensure that sufficient visibility can be achieved on both sides of the access road.

Problem Reference (Section 2)	Designer Response Section			Audit Team Response Section
	Problem Accepted (yes / no)	Recommended Measure Accepted (yes / no)	Alternative Measures or Comments	Alternative Measures Accepted (yes / no)
2.1	Yes	Yes	The vegetation either side of the access junction will be removed as recommended.	Comment noted and accepted.
2.2	Yes	Yes	The over-run area for abnormally sized loads will be closed as a default and opened only on the nights that the abnormally sized loads are delivered, which will be accompanied with a Garda escort.	Comment noted and accepted.

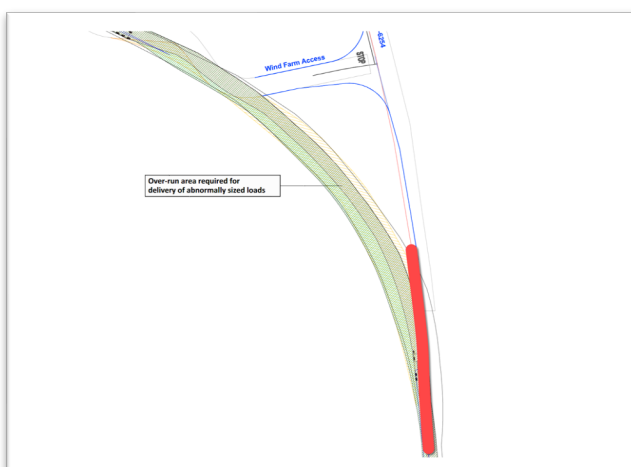
2.2 Problem: Passing Motorists Accessing the Via Overrun Area

Location: Overrun Area to South of L-6254 Access Road Junction

The over-run area might create confusion for passing motorists, who could access the overrun area by mistake, leading to sudden braking, loss of control or conflicts with construction traffic.

Figure 2.2 – Location Where Passing Motorists Could Access the Overrun Area (When Not in Use)

The Designer should ensure that a suitable barrier is put in place to prevent passing motorists from accessing the abnormal load overrun area when it is not in use.
