***PEAT STABILITY RISK  
ASSESSMENT (FT 2026)***

# GEOTECHNICAL & PEAT STABILITY REPORT

## CAHERMURPHY WEST WIND FARM

**Document No:**  
P23230-FT-EGT-XX-RP-GE-0001

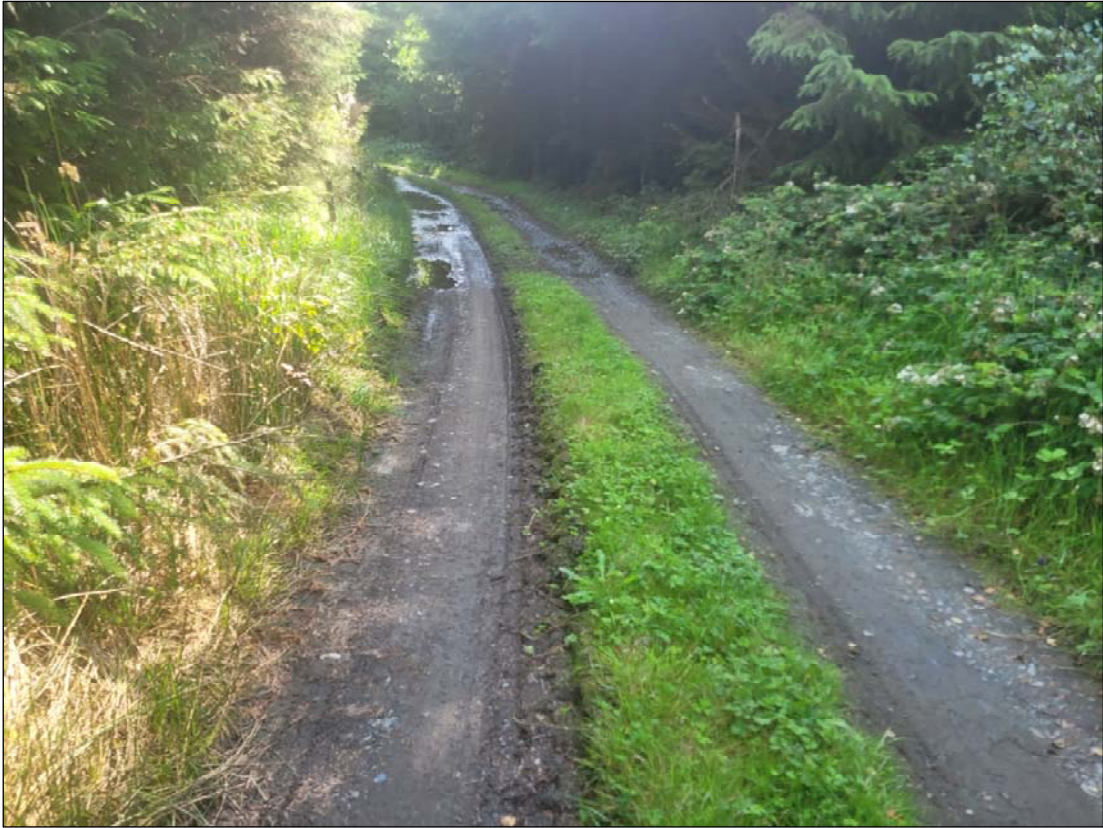
**Photo 1:** Existing track at construction compound

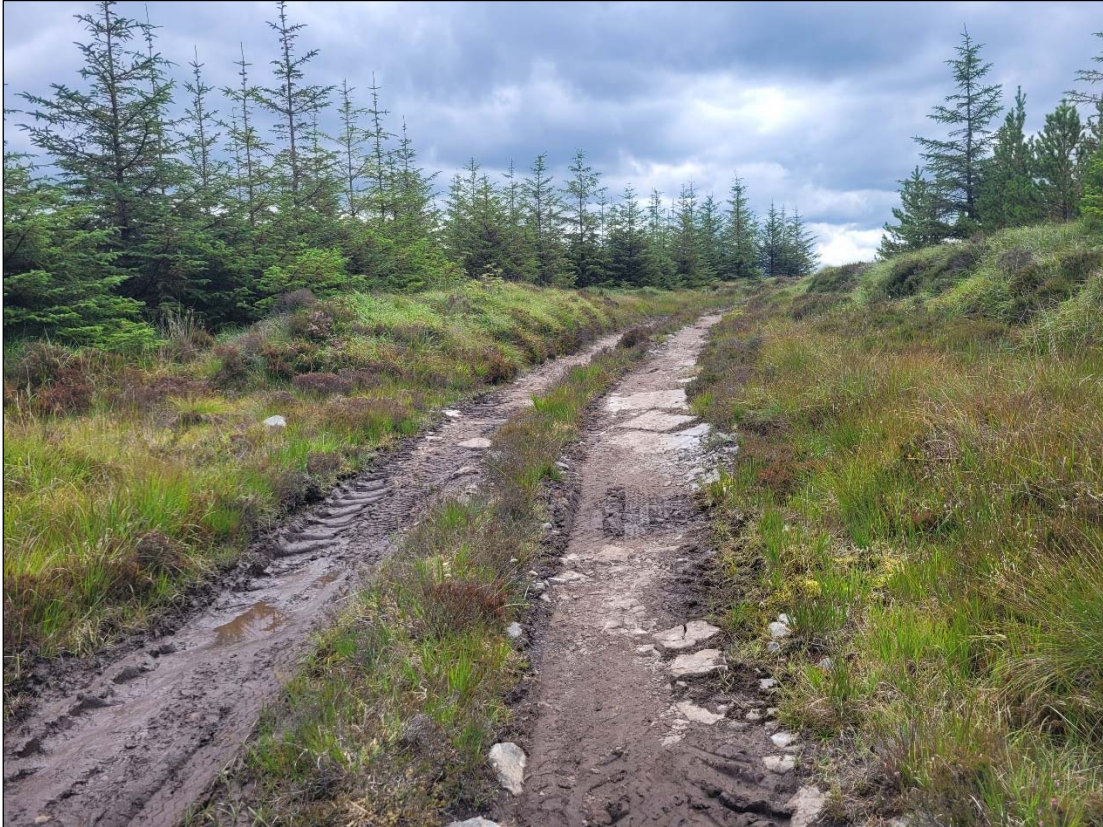
**Photo 2:** Existing track north of T05

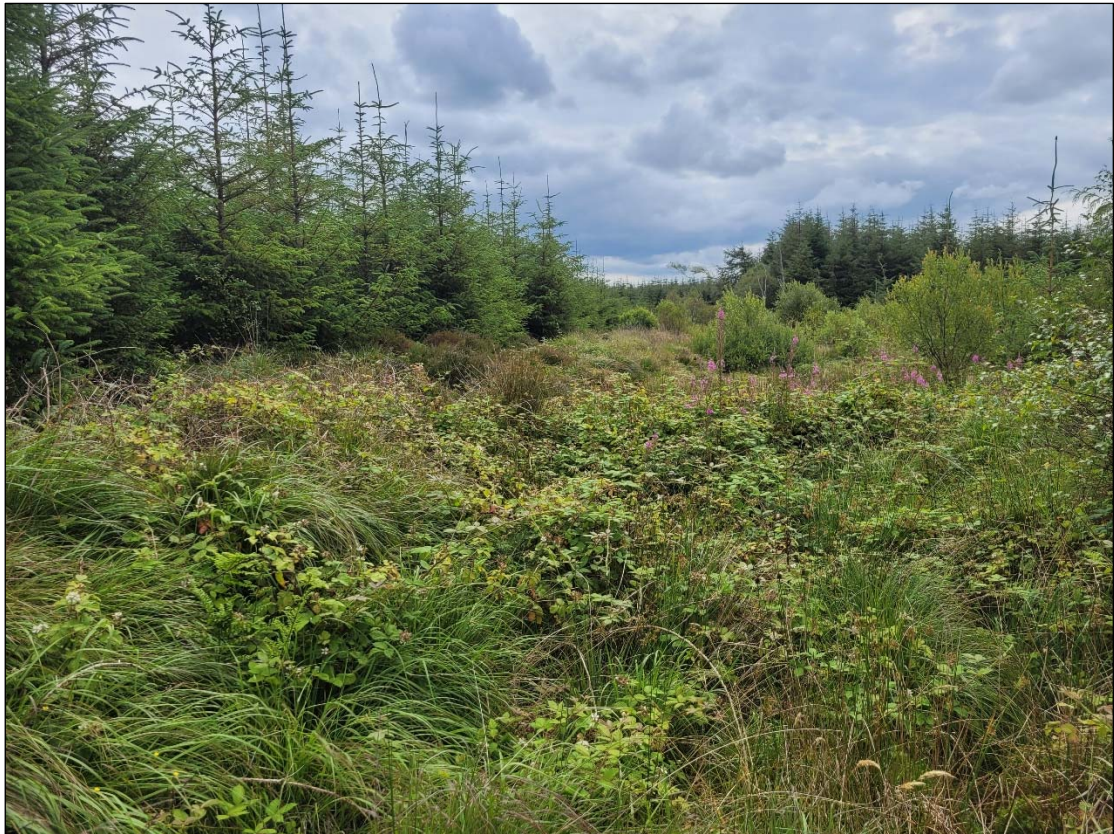
**Photo 3:** Along access route to T04

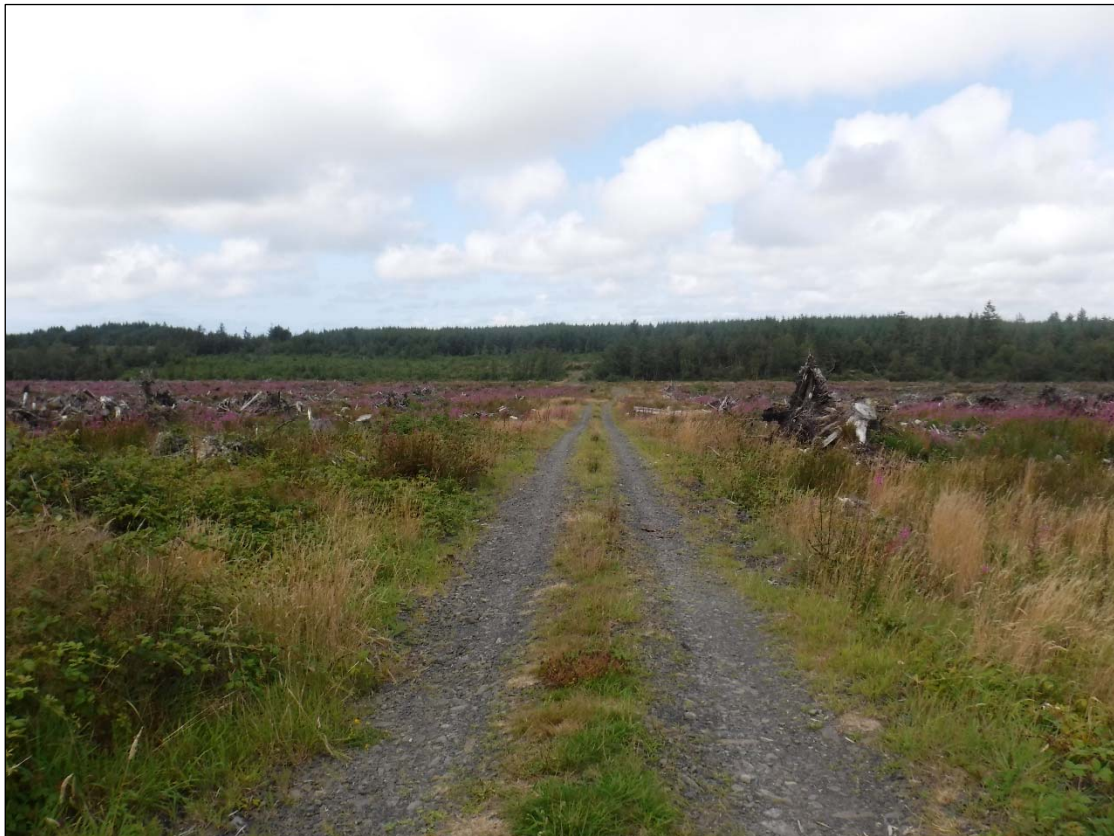
**Photo 4:** Looking North along existing access road at T07
